CONDOMINIUM INSPECTION REPORT

12155 Metro Pkwy

Fort Myers, FL

Property Inspection Report

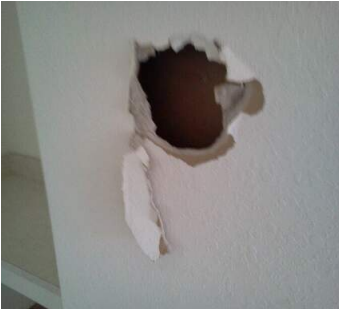
1.

Location: Living Room **System:** Interior **Condition:** Physical impact damage noted in wall surface finish.

Explanation: Physical damage is noted to the wall surface finish. Damage of this nature is usually the result of impact. No structural damage is suspected.

Impact Consequences: The nature of the damage is typically cosmetic in nature. Surface repairs should be considered to establish a visually acceptable wall finish.

Recommended Action: Repair

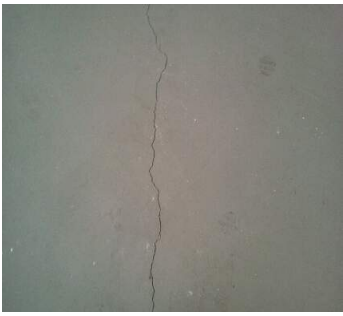
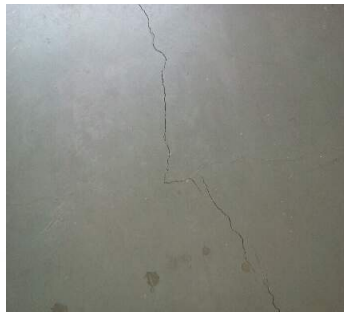
1.

Location: Garage **System:** Exterior **Condition:** Garage concrete floor displays typical settlement

Explanation: Settlement of the garage concrete pad is an indication of insufficient pad thickness. Other causes may include soil compaction soils with low bearing capacity and ground heave. Settlement as a condition by itself does not usually result in garage structure issues. Settlement combined with other structural concerns often indicates the garage as a whole may no longer be structurally sound.

Impact Consequences: Settlement cracks in garage floor should be monitored for change over time. Should cracks result in possible trip hazards a specialist should be consulted for repair.

Recommended Action: Review

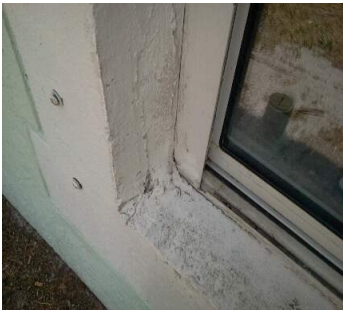
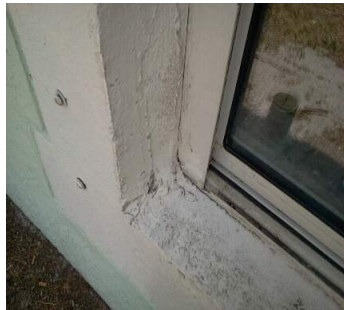
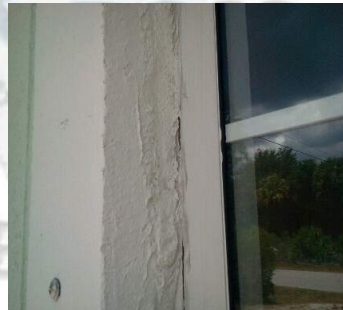
2.

Location: Throughout **System:** Exterior **Condition:** Window caulking is deteriorated

Explanation: The window caulking is observed to be deteriorated. Caulking that is cracked embrittled or missing requires preventative maintenance actions to ensure the window frames will maintain a weathertight seal at the junction areas of window frame through the exterior wall.

Impact Consequences: Caulking at window frames serves several functions including preventing air water and pest infiltration and restricting heat loss or gain through the exterior wall. Moisture has the greatest potential for damage; unintended water infiltration into the house can cause significant damage to surfaces and property and if not corrected may lead to damage and rot to structural elements. Caulking repairs are required at the noted location(s) and should be performed at the earliest opportunity. Preventative maintenance should include reviewing and repairing exterior caulking at doors windows and wall penetrations at least twice a

Recommended Action: Repair

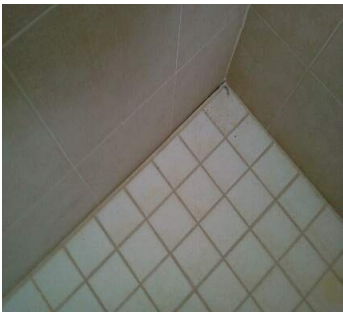
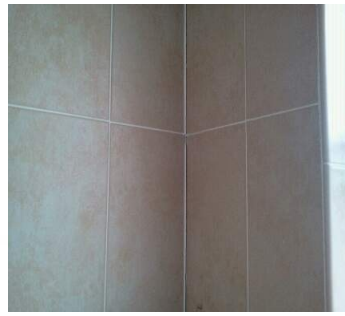
- 1.

Location: Main Bathroom **System:** Plumbing **Condition:** Shower enclosure has grout that is incomplete or open between tiles

Explanation: The purpose of grout is to prevent water penetration between the edges of tiles at the shower area. Grouting is observed to be inadequate to meet the intended requirements for sealing against water leakage.

Impact Consequences: Grouting is required to complete the cosmetic appearance of a tiled area and to serve to prevent water from seeping between tiles and into walls and floors. Failure to provide effective grout application can result in damage and costly repairs due to water leaks behind and below finished areas.

Recommended Action: Repair

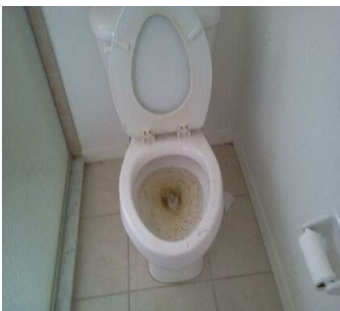
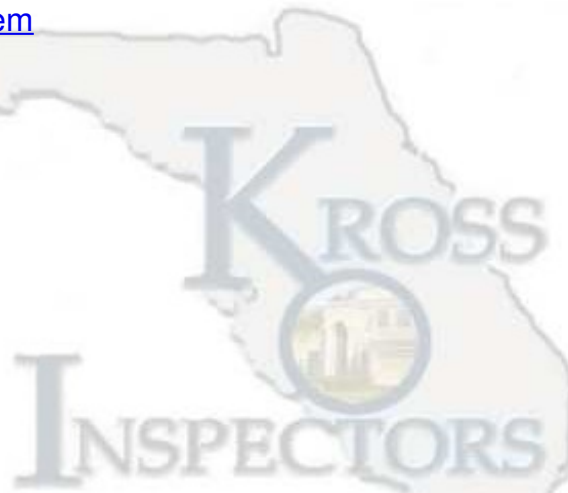
2.

Location: Main Bathroom **System:** Plumbing **Condition:** Toilet valve runs on when tank is full

Explanation: The toilet is observed to continue to run on when the tank is full.

Impact Consequences: This condition creates unnecessary waste of water and the noise of the continually running water can be an annoyance. The toilet valve does not achieve its intended function of turning off the water supply fully when the tank is full.

Recommended Action: Repair
